STAINED-GLASS PROTECTION

Proper ventilation is one of the essential factors to consider when installing glazing systems to protect stained-glass windows.

By Ron Bovard

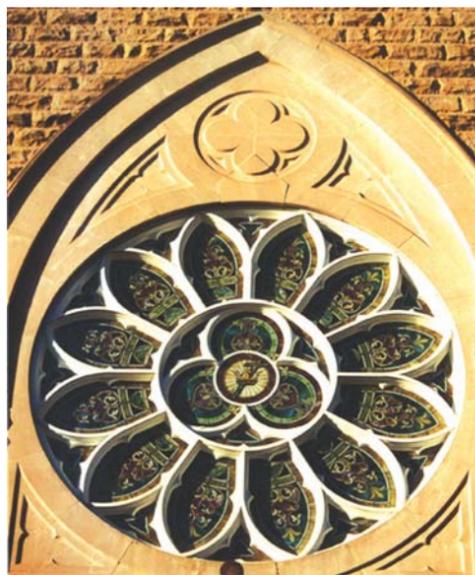
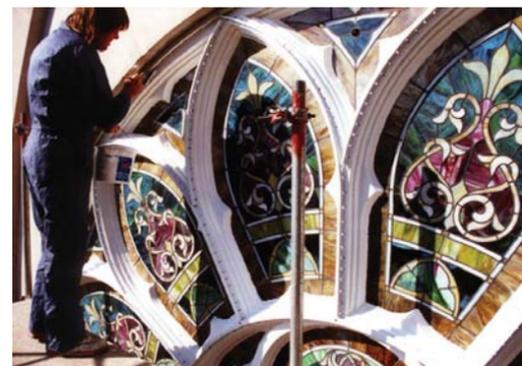
This rose window aluminum protective glazing system was designed to match the frame's tracery in an outset system at First United Methodist Church, Iowa City, IA.

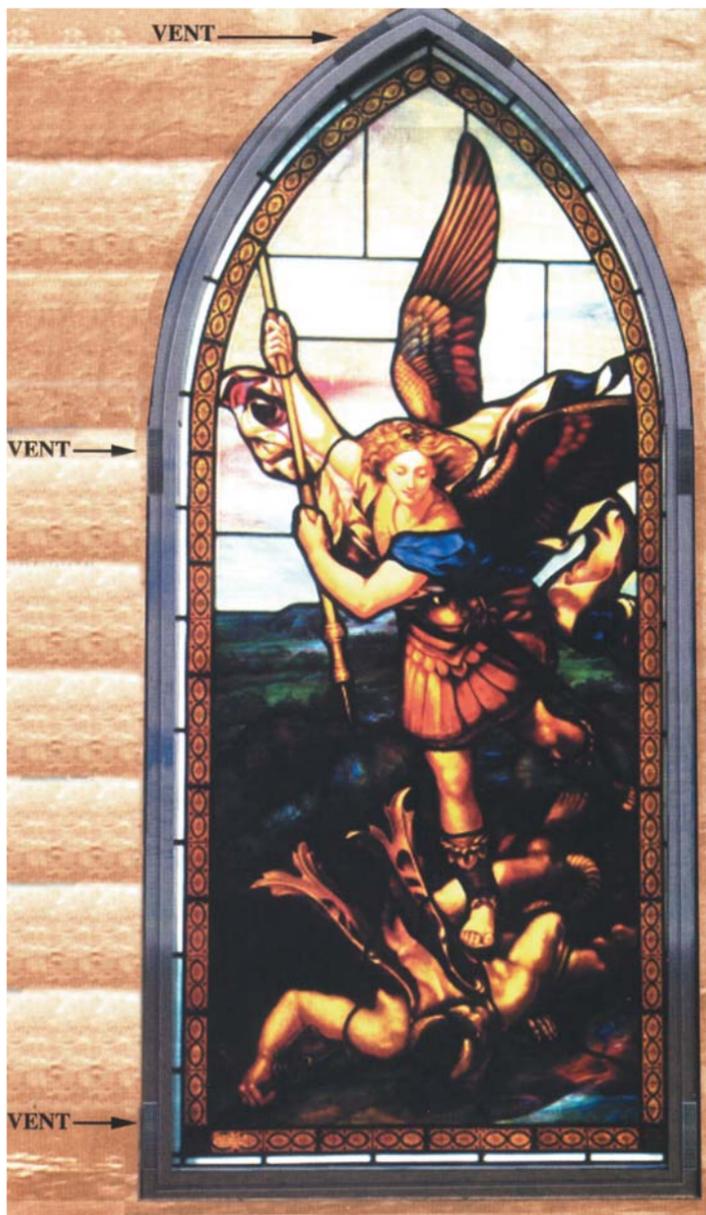
An aluminum-frame ventilation system was installed in this stained-glass window in a private chapel in Wichita, KS.

Expansion and contraction cycles deteriorate most building materials, including stained-glass windows, causing reinforcing systems to fail, bulging and cracking of the stained glass and premature metal fatigue and deterioration of the lead in a stained-glass window. In a tightly sealed glazing system in a new properly cemented stained-glass window, the increased pressure from the heated air space between the window and protective glazing can contribute to the deflection of the stained-glass window. Proper venting is critically important for the preservation of your stained-glass heritage. One sq.in. of ventilation at the top and bottom of the stained-glass window is the minimum ventilation recommended for 16 sq.ft. of stained glass in a protective glazing system.

From our observations made while restoring stained-glass windows with these types of problems, the less the space between the window and the unvented protective covering, the more severe the damage becomes. However, a minimum of a 1-in. air space between the window and protective glazing is needed for the effective conservation of the stained-glass window. The greater the space, the less severe the damage. A quick inspection will give clear evidence if a moisture problem exists. From the outside of the building, look at the surface of the lead behind the single-glazed protective covering. If you detect a white "lead oxide" powder (the equivalent of rust
